# CASE HISTORY

# Roton Boat Club Dock Repair

HELICAL PILES INSTALLED IN LIMITED WINDOWS OF TIME AND REDUCED OVERALL PROJECT COSTS

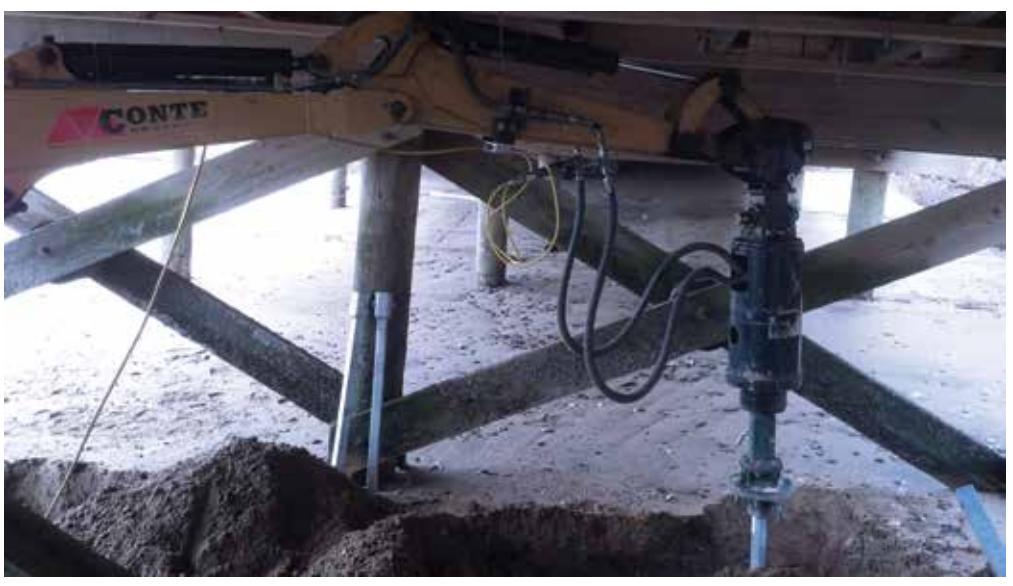
Eight CHANCE<sup>®</sup> Helical Piers were installed under a dock with limited clearance (seven feet) during low tide.

Danbro Distributors of Philadelphia, PA, provided the CHANCE SS175 Helical Piles to Conte Company with 10, 12, and 14 inch helical plates. Ideal for rocky soil conditions, each pile was screwed down to a depth of approximately 10 feet and a torque rating of 2,500 to 3,000 foot-pounds.

A turnbuckle was attached to the top of each pile and new wooden posts were installed and tied into the dock.

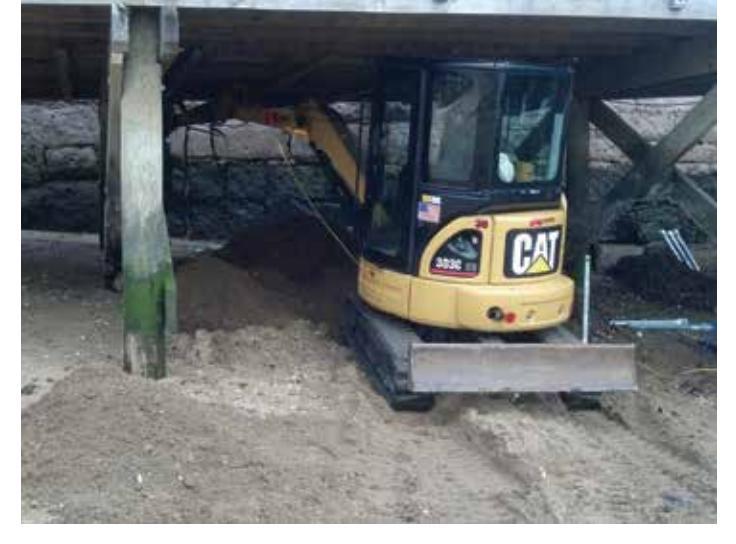
"We drove our CAT 303, mini-excavator (with a Pengo 12K drilling head) down a small boat ramp to the beach, then across the beach and under the dock. The wet sand was pretty stiff, so getting bogged down wasn't a problem. Head room was. There was only 7 or 8 feet,

SUPERIOR TENSILE STRENGTH FOUND IN CHANCE HELICAL PILES ALLOW FOR ADDITIONAL PROTECTION AGAINST FUTURE STORM SURGE DAMAGE

which was just enough room to lift the boom of our excavator. Superior tensile strength found in CHANCE Helical Piles allow for additional protection against future storm surge damage," says Conte.
